Miscellaneous Paper CERC-96-3
May 1996

Physical Model Study of Breakwater Stability, Kodiak, Alaska

Prepared for U.S. Army Engineer District, Alaska

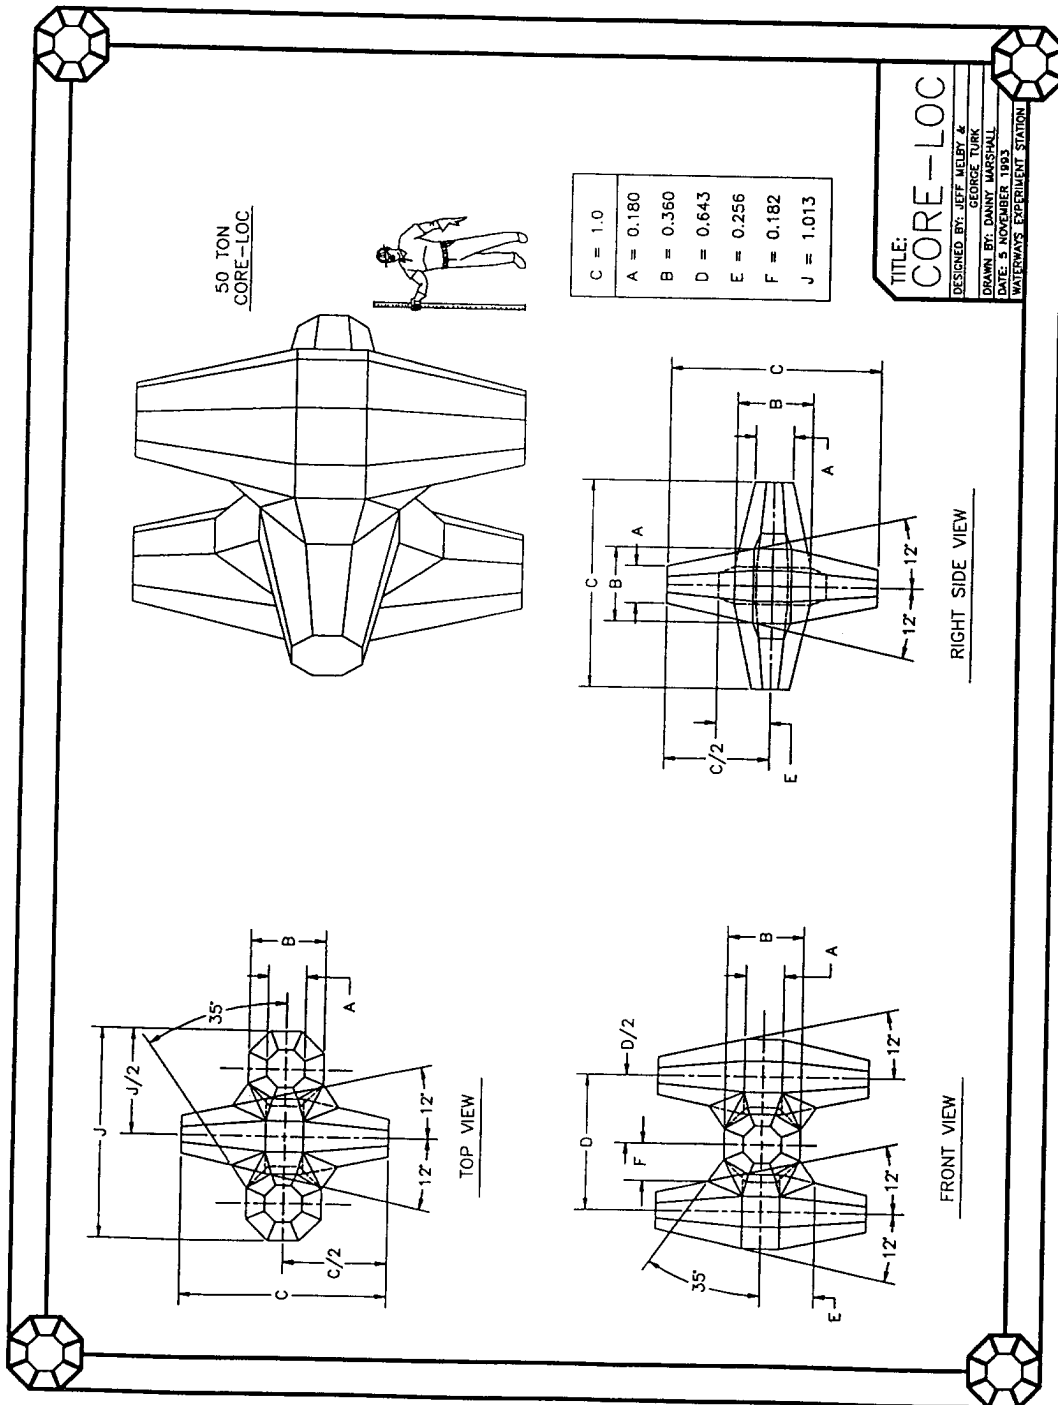
Figure 2. Core-Loc concrete armor units

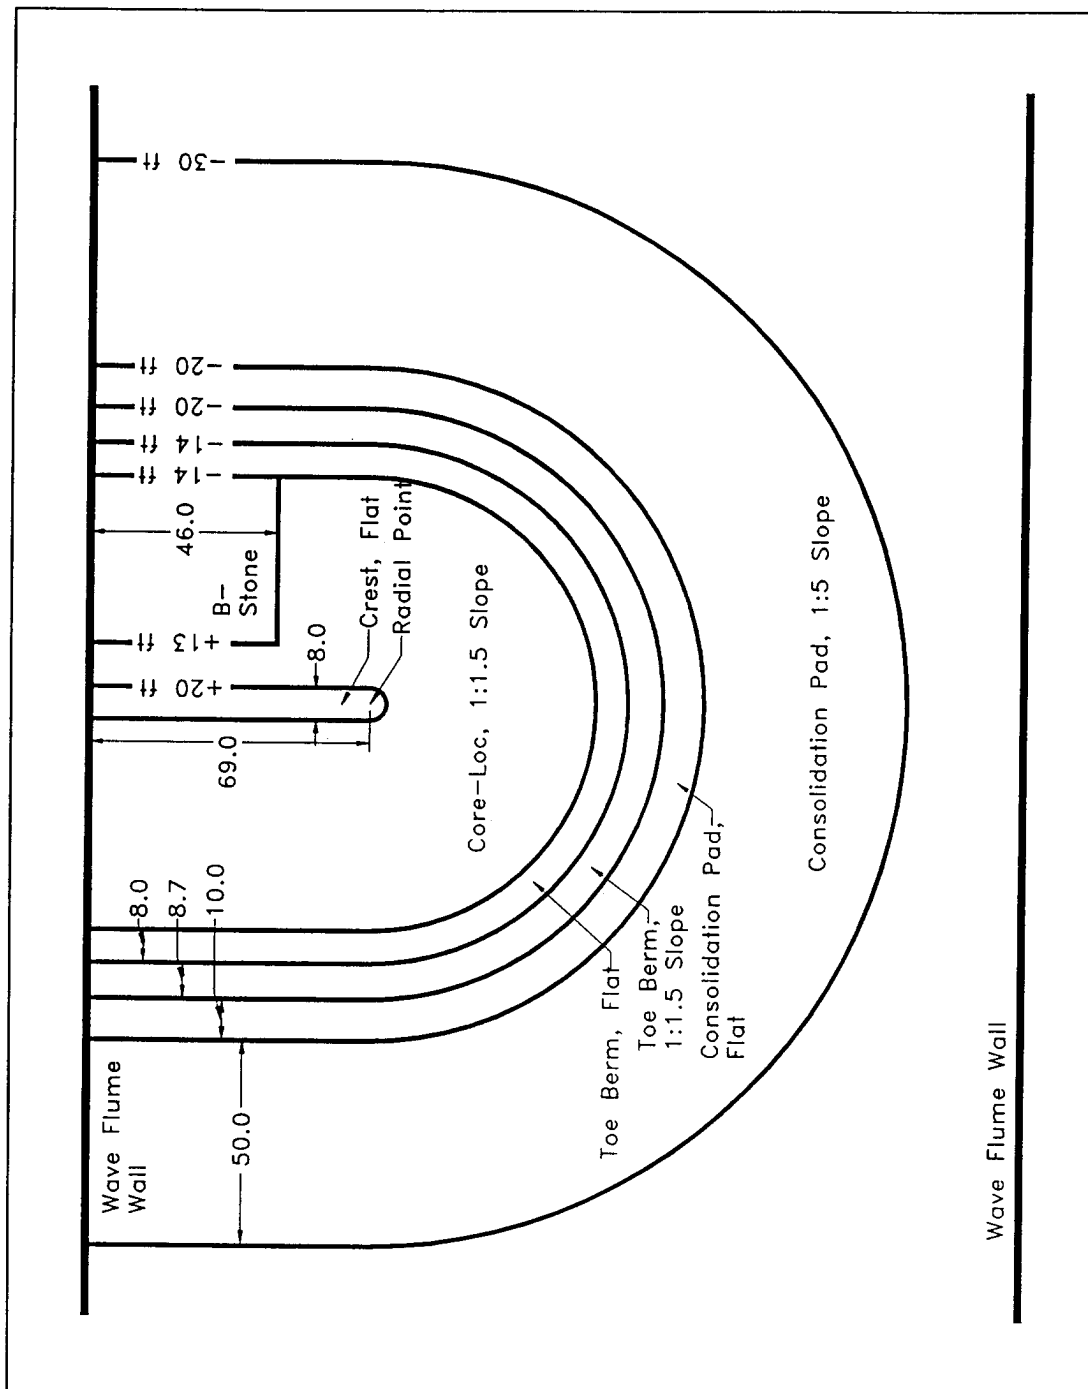
Figure 3. Overhead view of Plan 1 in test flume

Primary concern of the model tests was stability of the structure head. Due to refraction, angle of incidence, and other 3-D effects, structure head tests are normally conducted in a 3-D wave basin. However, there were no 3-D wave basins available at CERC during the time frame in which the physical model tests were required. It was therefore decided to construct the model head extending out from one wall of one of the largest two-dimensional (2-D) wave flumes at CERC. The model would extend part-way across the flume, perpendicular to the flume walls, allowing wave action to be channeled past the model head. Because the stub breakwater at the prototype also will channel wave action past the main breakwater head, the "quasi-3-D" representation in the 2-D wave flume was thought to be adequate. The model would include the main breakwater head plus part of the breakwater trunk. Figure 3 illustrates the quasi-3-D nature of the test with an overhead view of Plan 1 in the test flume.

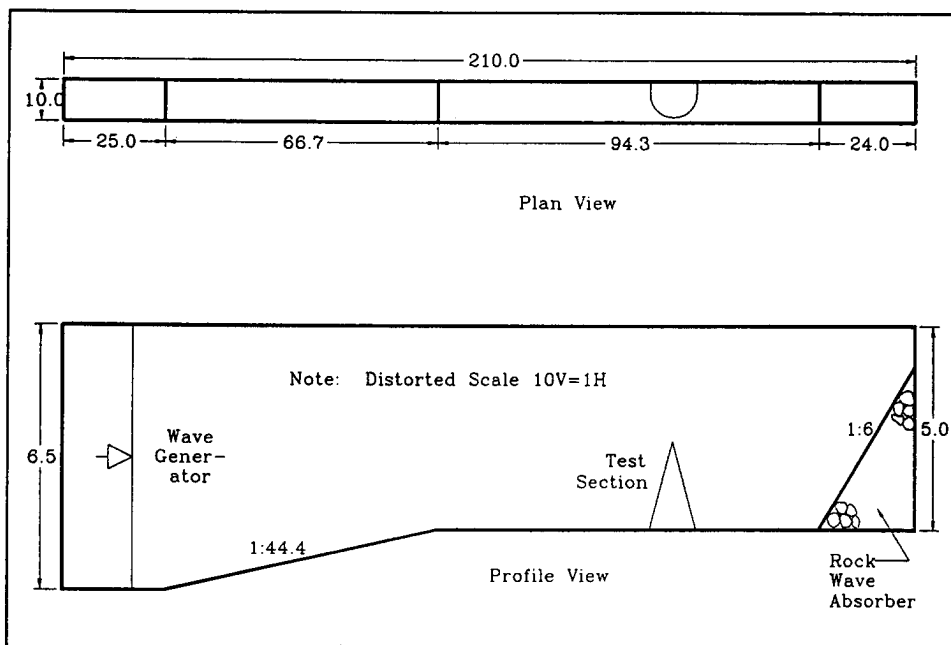
Figure 4. Two-dimensional test flume

Physical model tests were conducted in a 64-m-long (210-ft-long) by 3.0-m-wide (10-ft-wide) wave flume (Figure 4). The flume includes a 36-m-long (118.3-ft-long) by 1.5-m-deep (5-ft-deep) test section, then slopes at 1V:44.4H to a depth of 2.0 m (6.5 ft) at the wave generator. Waves were generated by a piston-type wave board powered by an electro-hydraulic pump controlled by a computer-generated signal. Capacitance-type wave gauges were placed in a three-gauge array in front of the wave board to record the generated wave train, with another three-gauge array located in front of the test structure to record wave trains near the structure. Three-gauge arrays were

used to permit separation of incident and reflected wave trains by the method of Goda and Suzuki (1976).¹ Flume bottom was set at -9.1 m (-30 ft) mllw. Bathymetry was not molded into the flume.

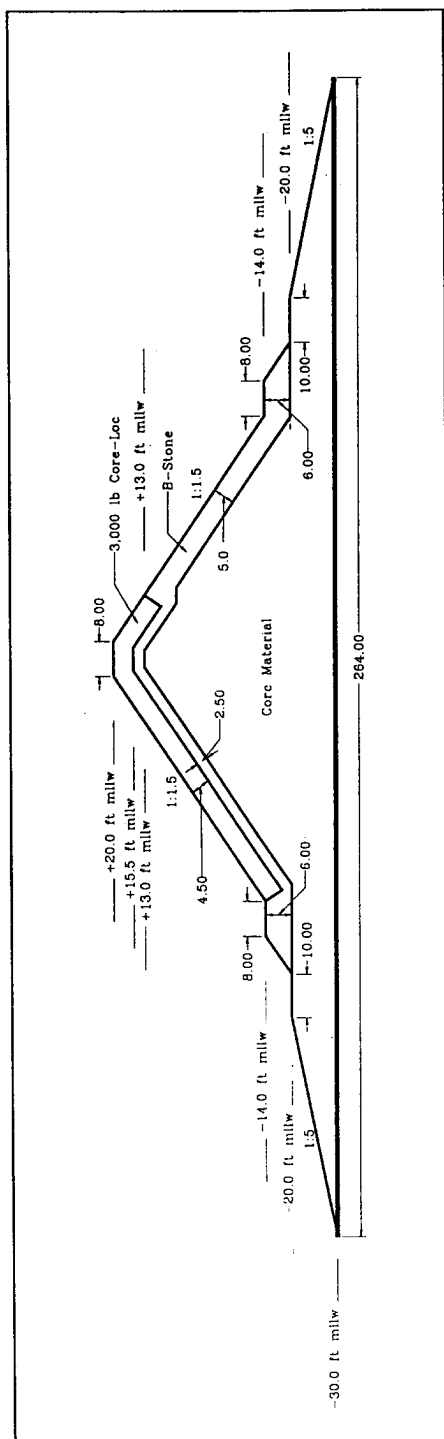
Figure 5. Cross section of breakwater trunk, Plan 1

B-stone in the original plans (with stone as primary armor units) was specified as 140 to 770 kg (300 to 1,700 lb) with $W_{50} = 340$ kg (750 lb). With the change to Core-Locs, size of the B-stone was reduced to 140 to 270 kg (300 to 600 lb). Core-Locs were placed on the structure head and on the sea side of the structure trunk, then across the crest of the trunk and down the harbor side to +4.0 m (+13 ft) mllw. B-stone was used for the underlayer beneath Core-Locs and for outer armor stone on the harbor-side trunk below +4.0 m (+13 ft) mllw. A cross section of the model trunk (in prototype units) is shown in Figure 5; a cross section of the model head is shown in Figure 6. Photos 5, 6, and 7 show Plan 1 before testing from sea side, end view, and harbor side, respectively.

Plan 2 used the same cross sections as Plan 1 (Figures 5 and 6), but replaced B-stone on the harbor-side trunk with larger B-stone weighing 140 to 770 kg (300 to 1,700 lb) with $W_{50} = 340$ kg (750 lb) to stabilize the harbor-side trunk. B-stone beneath Core-Locs was not replaced. All Core-Locs were removed from the structure crest and harbor side, but structure head and sea-side slope were not rebuilt. Due to settling and compacting of Core-Locs on the head and sea-side slope, 15 additional Core-Locs were required to rebuild the structure crest. The first row of Core-Locs above B-stone on the harbor-side trunk was not uniformly placed as in Plan 1, but stones were randomly placed for the entire rebuild of the structure.

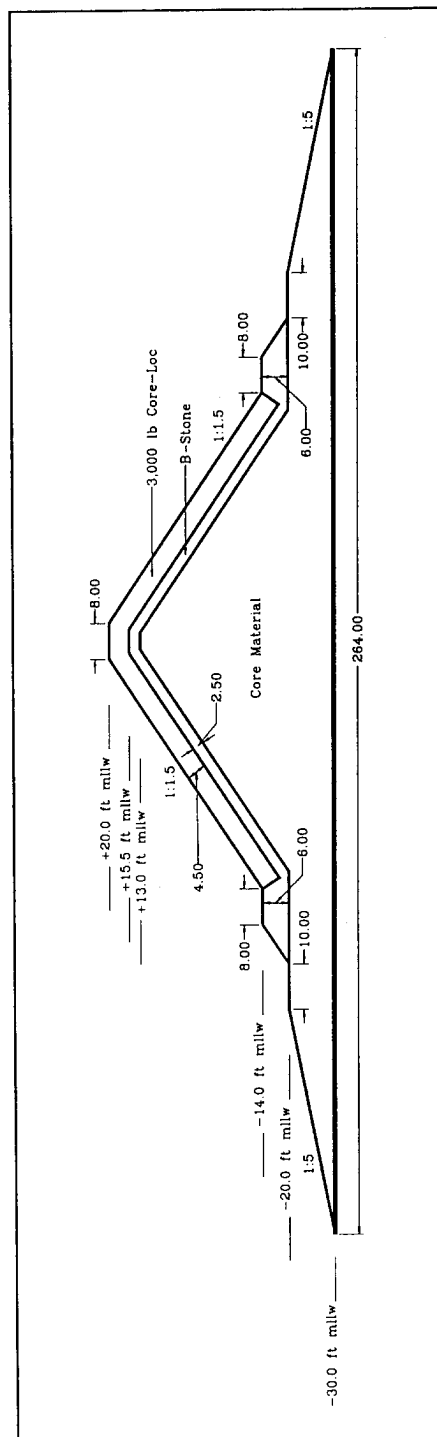
Figure 6. Cross section of breakwater head, Plan 1

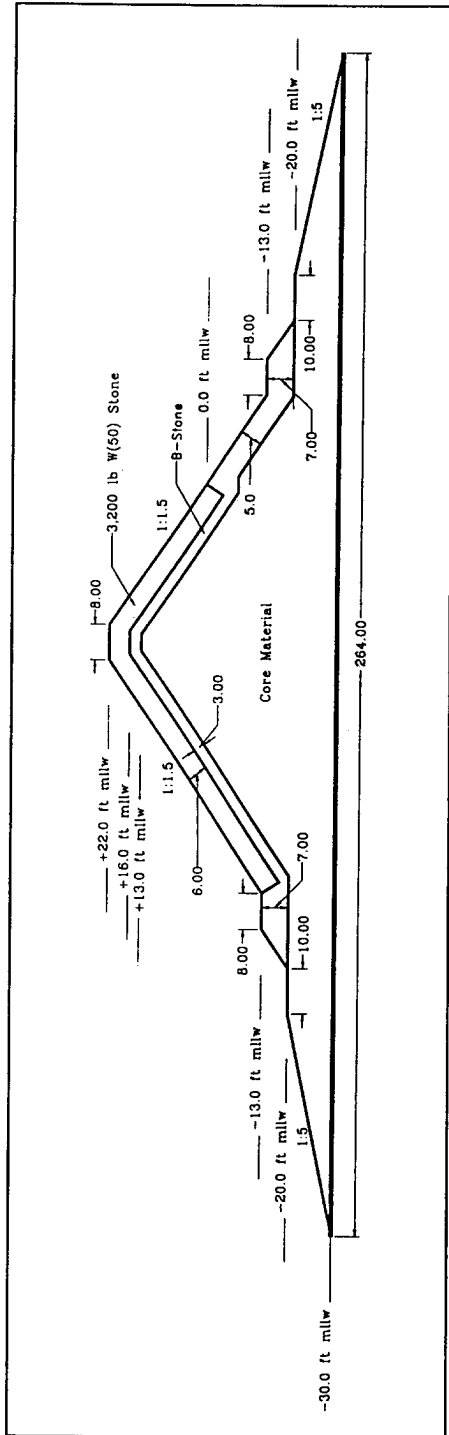
Figure 8. Cross section, breakwater trunk, Plan 5

Plan 5 used armor stone instead of Core-Locs for primary armoring of the structure. All Core-Locs were removed from the structure and the underlayer was smoothed and reshaped as necessary. A double layer of armor stone with $W_{s0} = 1,450$ kg (3,200 lb) was placed over the B-stone underlayer. Crest elevations of the structure core and underlayer were the same as in Plans 1, 2, 3, and 4, but the double layer of armor stones raised the final crest elevation higher than the single layer of Core-Locs used on earlier test configurations. Stones were placed in a manner similar to dropping each stone individually from a backhoe, and no attempt was made to specially place or key the stones. Stones used on the model were more uniform in size than would be expected on the prototype, with model stones typically within ± 10 percent of W_{s0} . Figure 8 shows a cross section of the Plan 5 trunk; Figure 9 shows a cross section of the Plan 5 head. The vertical panels of rubberized matting used in Plan 4 were used again in Plan 5. Photos 20, 21, and 22 show sea-side, end, and harbor-side views, respectively, of Plan 5 before testing.

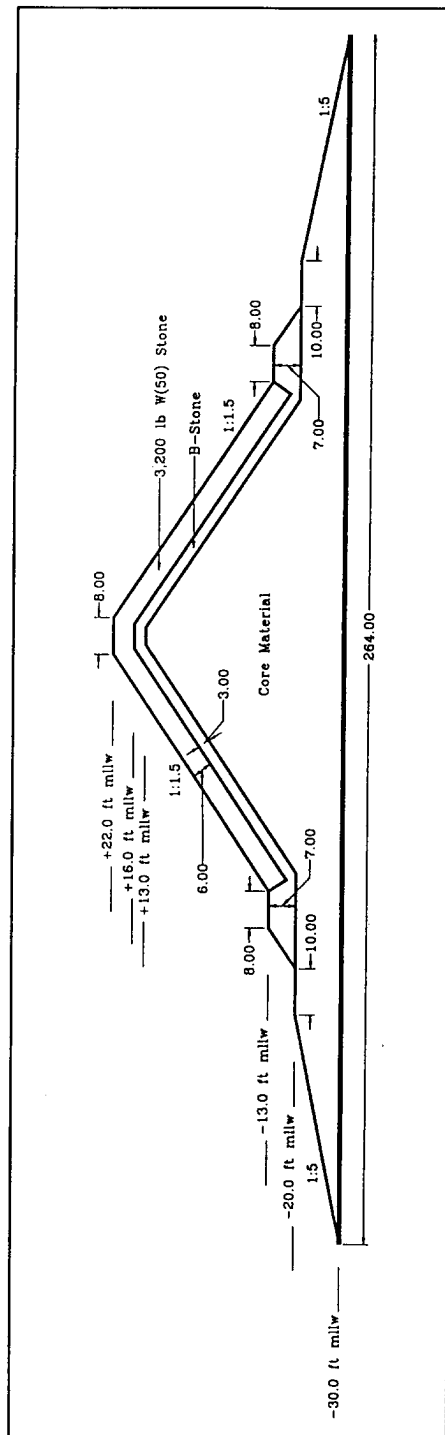
Figure 9. Cross section, breakwater head, Plan 5

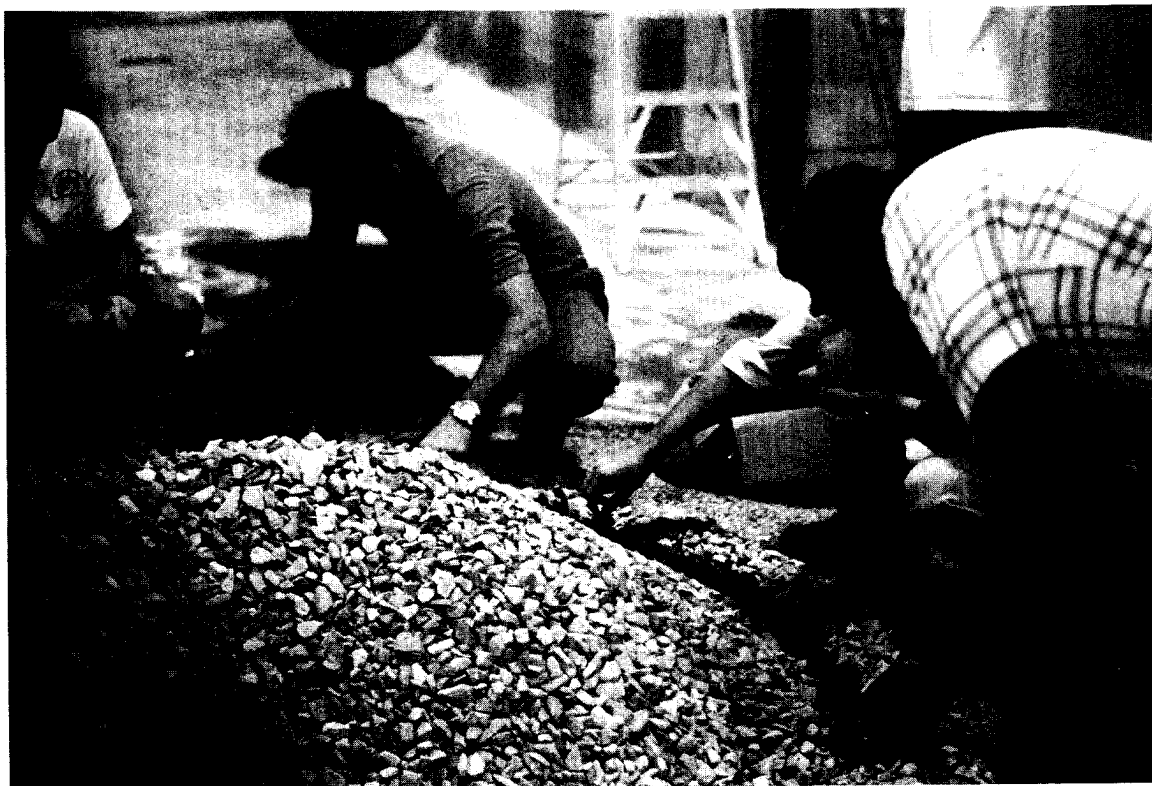
Photo 3. Placement of Core-Loc concrete armor units on model toe

Core-Locs along the toe were placed individually in a uniform pattern as shown in Photo 3. All Core-Locs placed above the toe row were randomly placed. On the harbor side, first row above B-stone also was uniformly placed as at the toe, with all subsequent rows randomly placed.

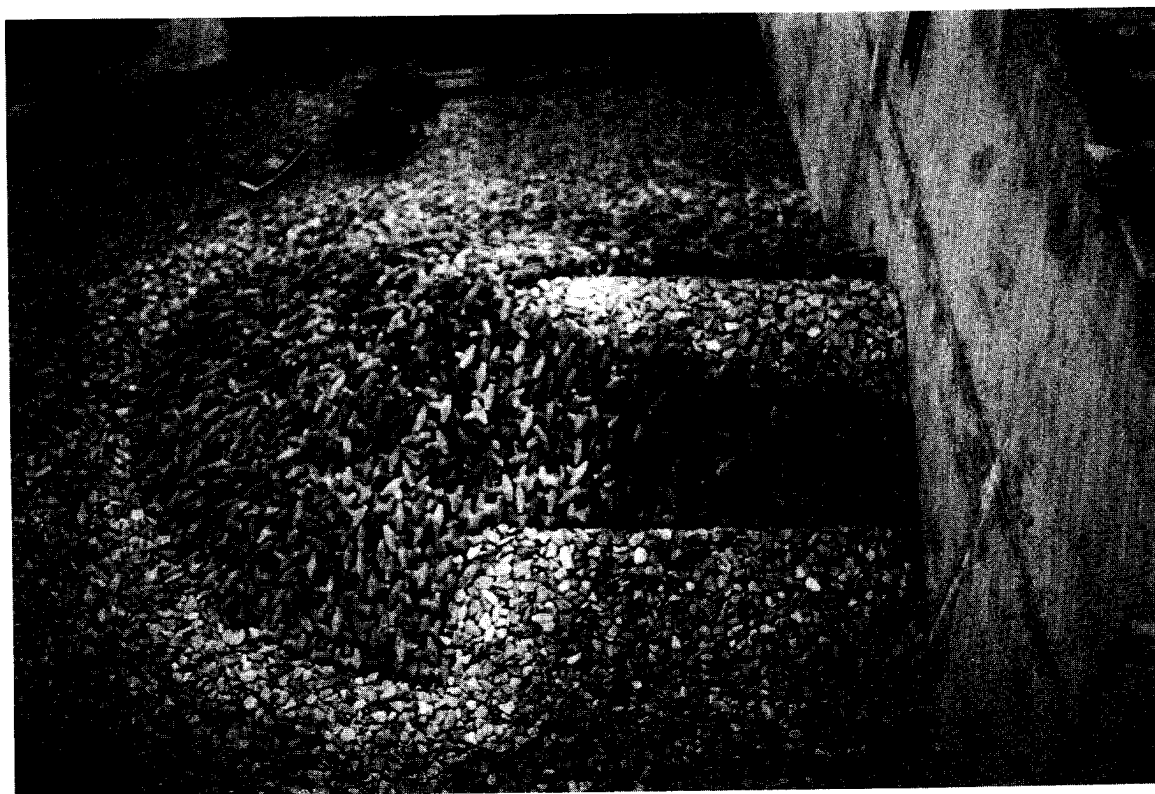
Photo 4. "Inverted V" placement technique for concrete armor units

Placement of Core-Locs on the structure crest followed an “inverted V” (Photo 4). Working from the head back along the crest, Core-Locs were placed in such a manner that they formed a “V” with the point on the crest pointing toward the head. Core-Locs were placed along each side of the structure such that the “V” shape moved along the structure crest from head back along the length of the trunk. This method, recommended by Messrs. Melby and Turk (inventors of the Core-Loc), appeared to produce a more consistent placement of units on the crest and reduced problems with a “seam” that occurs when armor units are placed up each side of the structure and meet at the crest. Where the sides meet, it is difficult to ensure that individual units are keyed into the matrix.

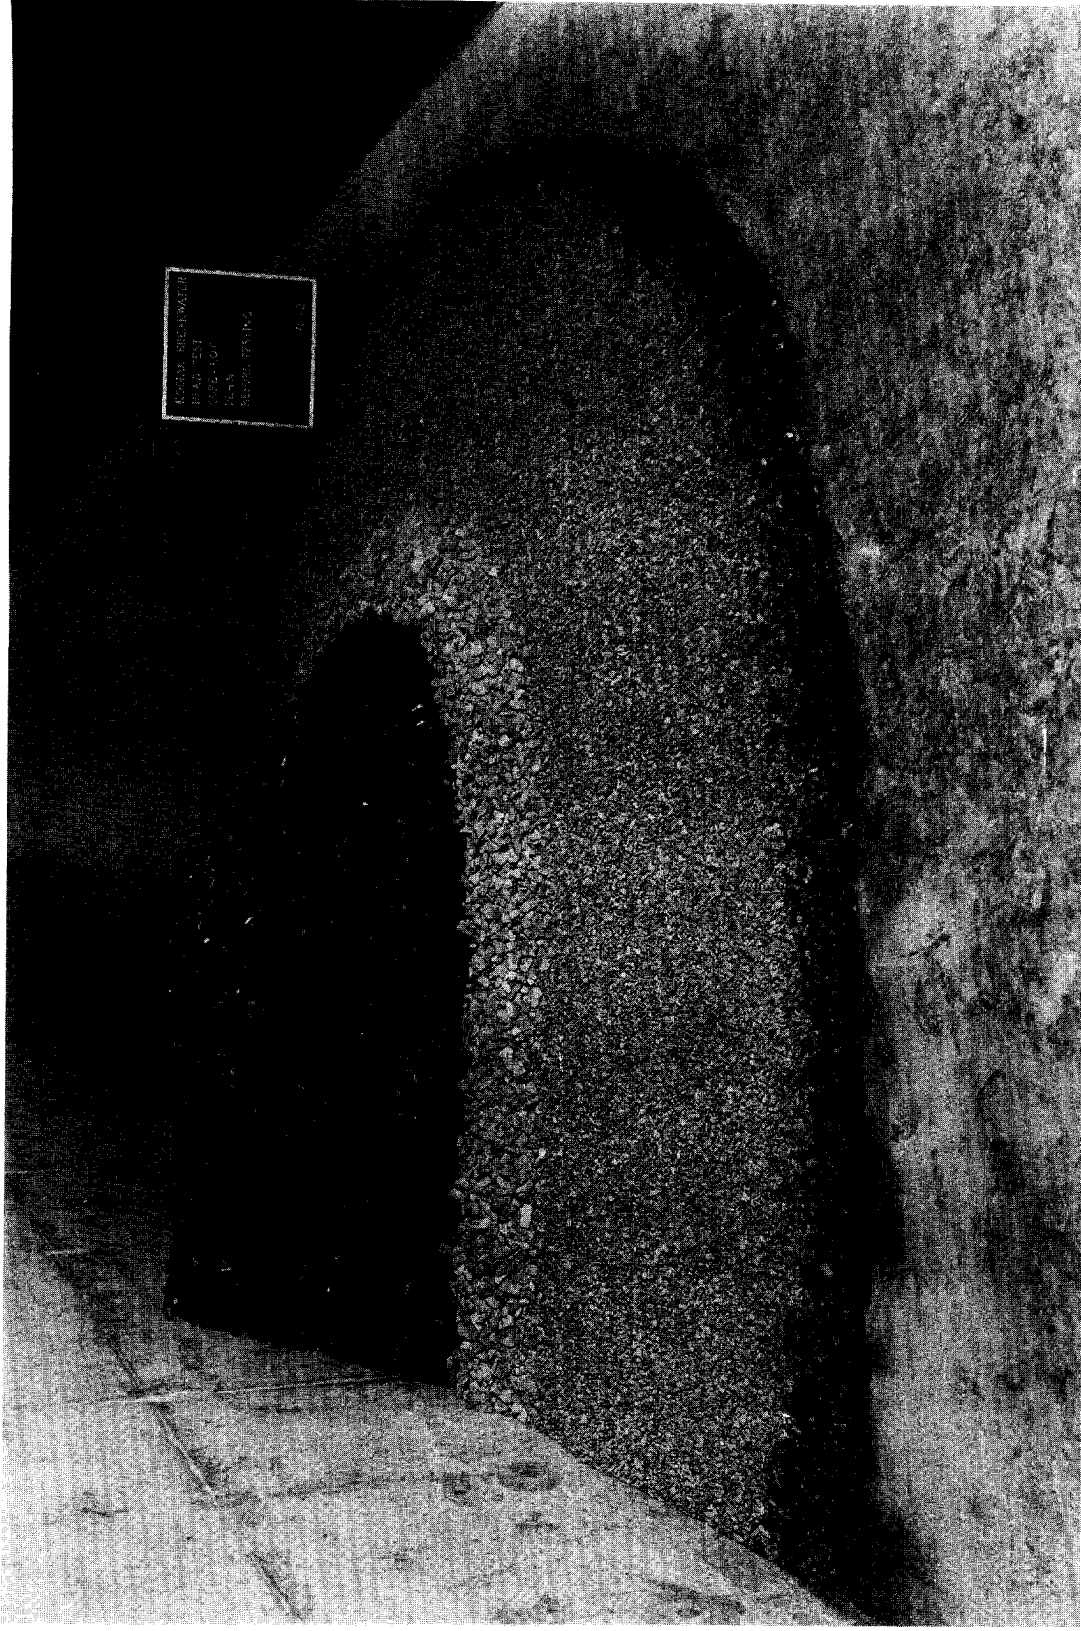
Photo 5. Sea-side view of model breakwater Plan 1 before testing

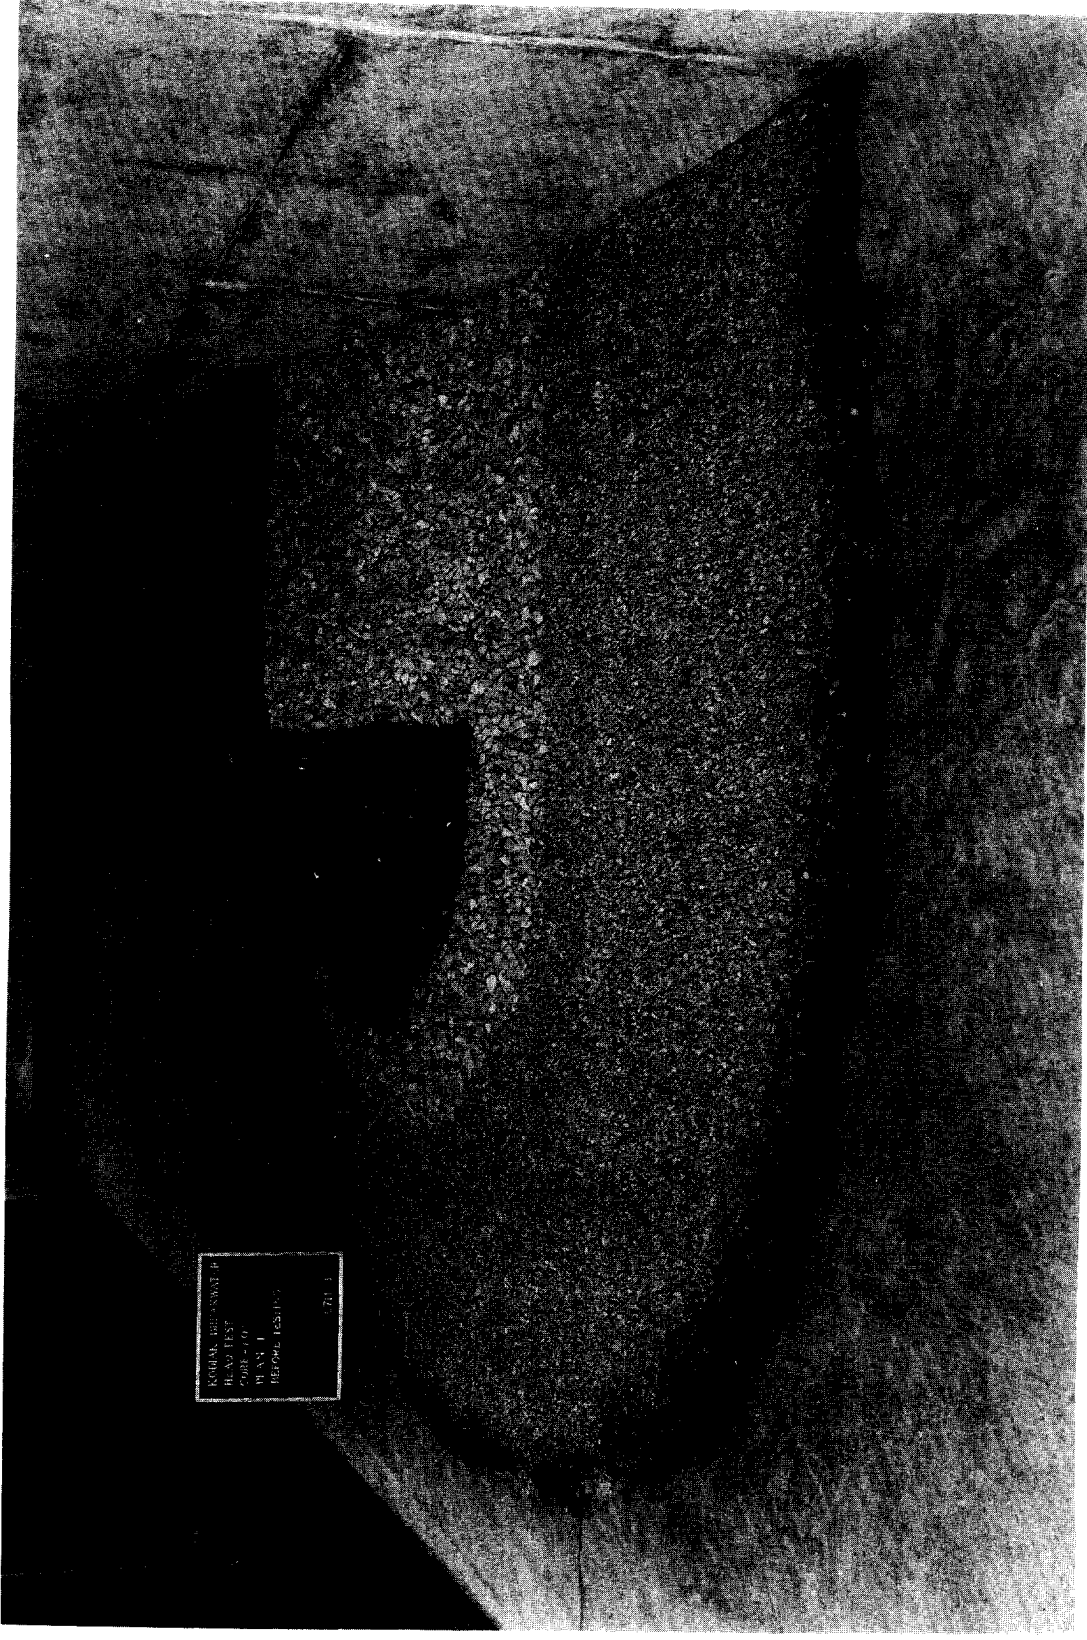
Photo 7. Harbor-side view of model breakwater Plan 1 before testing

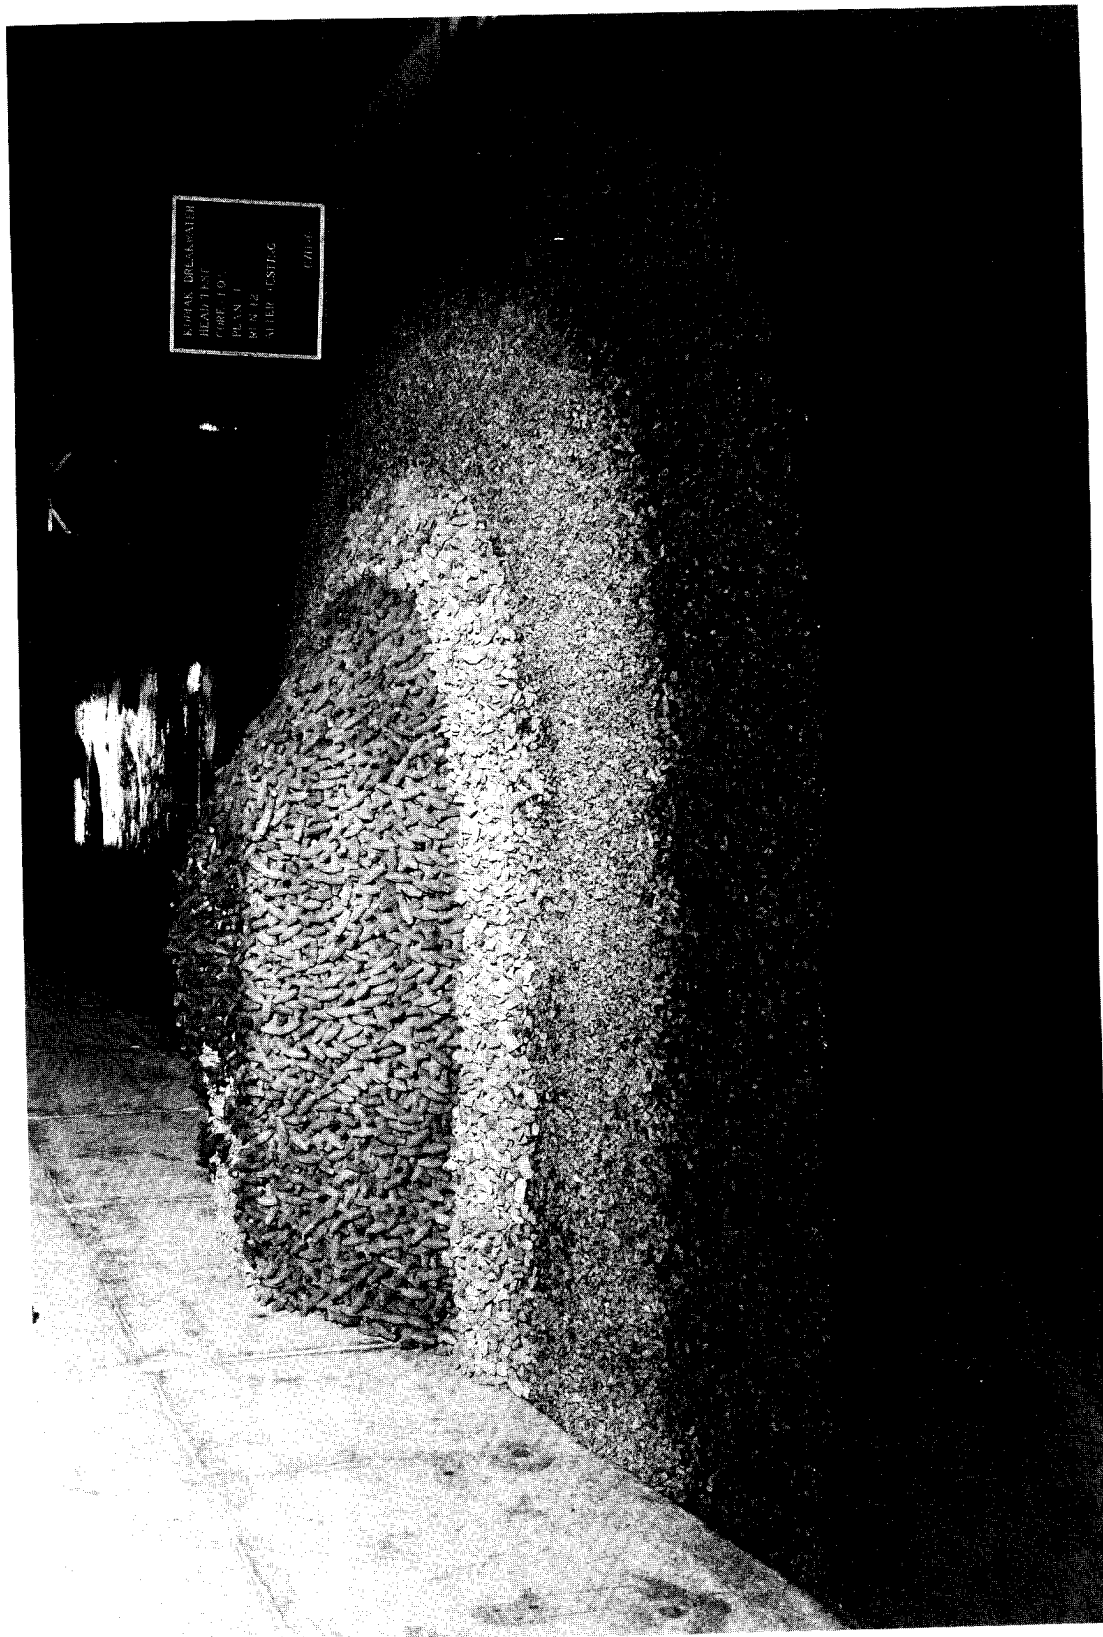
Photo 8. Sea-side view of model breakwater Plan 1 after testing

Due to damage sustained during the first two tests at $T_p = 7.0$ s and $H_{mo} = 2.4$ m (8.0 ft), it was decided not to conduct the third test at $T_p = 7.0$ s and $H_{mo} = 2.4$ m (8.0 ft), and instead to conduct tests at $T_p = 11.0$ s and $H_{mo} = 1.7$ m (5.5 ft). During the first 48-min test at $T_p = 11.0$ s and $H_{mo} = 1.7$ m (5.5 ft), B-stone sloughed on the harbor-side trunk, causing a massive failure. Core-Locs on the crest and harbor-side trunk were washed down into the area of the slough and damage extended down to core material. The head was undamaged, and there was no damage to the sea-side trunk below core elevation of 4.0 m mllw (+13 ft). No damage was observed to the toe, apron, or consolidation pad. Photos 8, 9, and 10 show Plan 1 after testing from the sea side, end view, and harbor side, respectively.

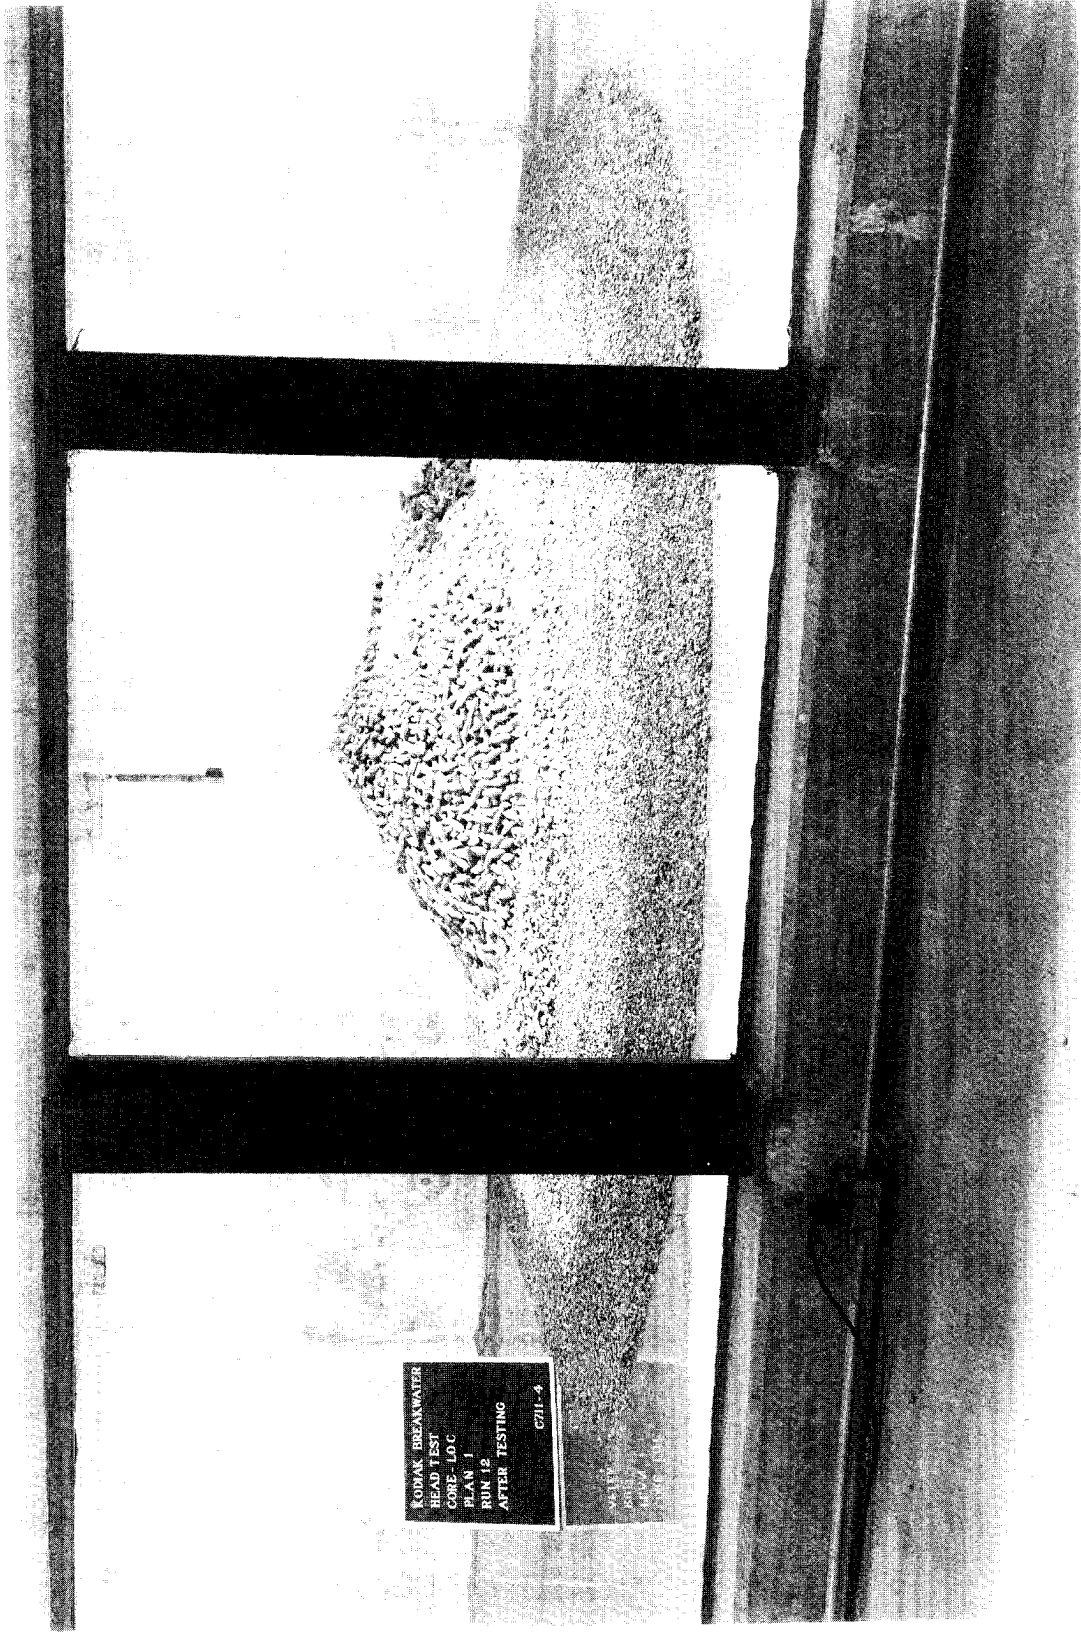
Photo 9. End view of model breakwater Plan 1 after testing

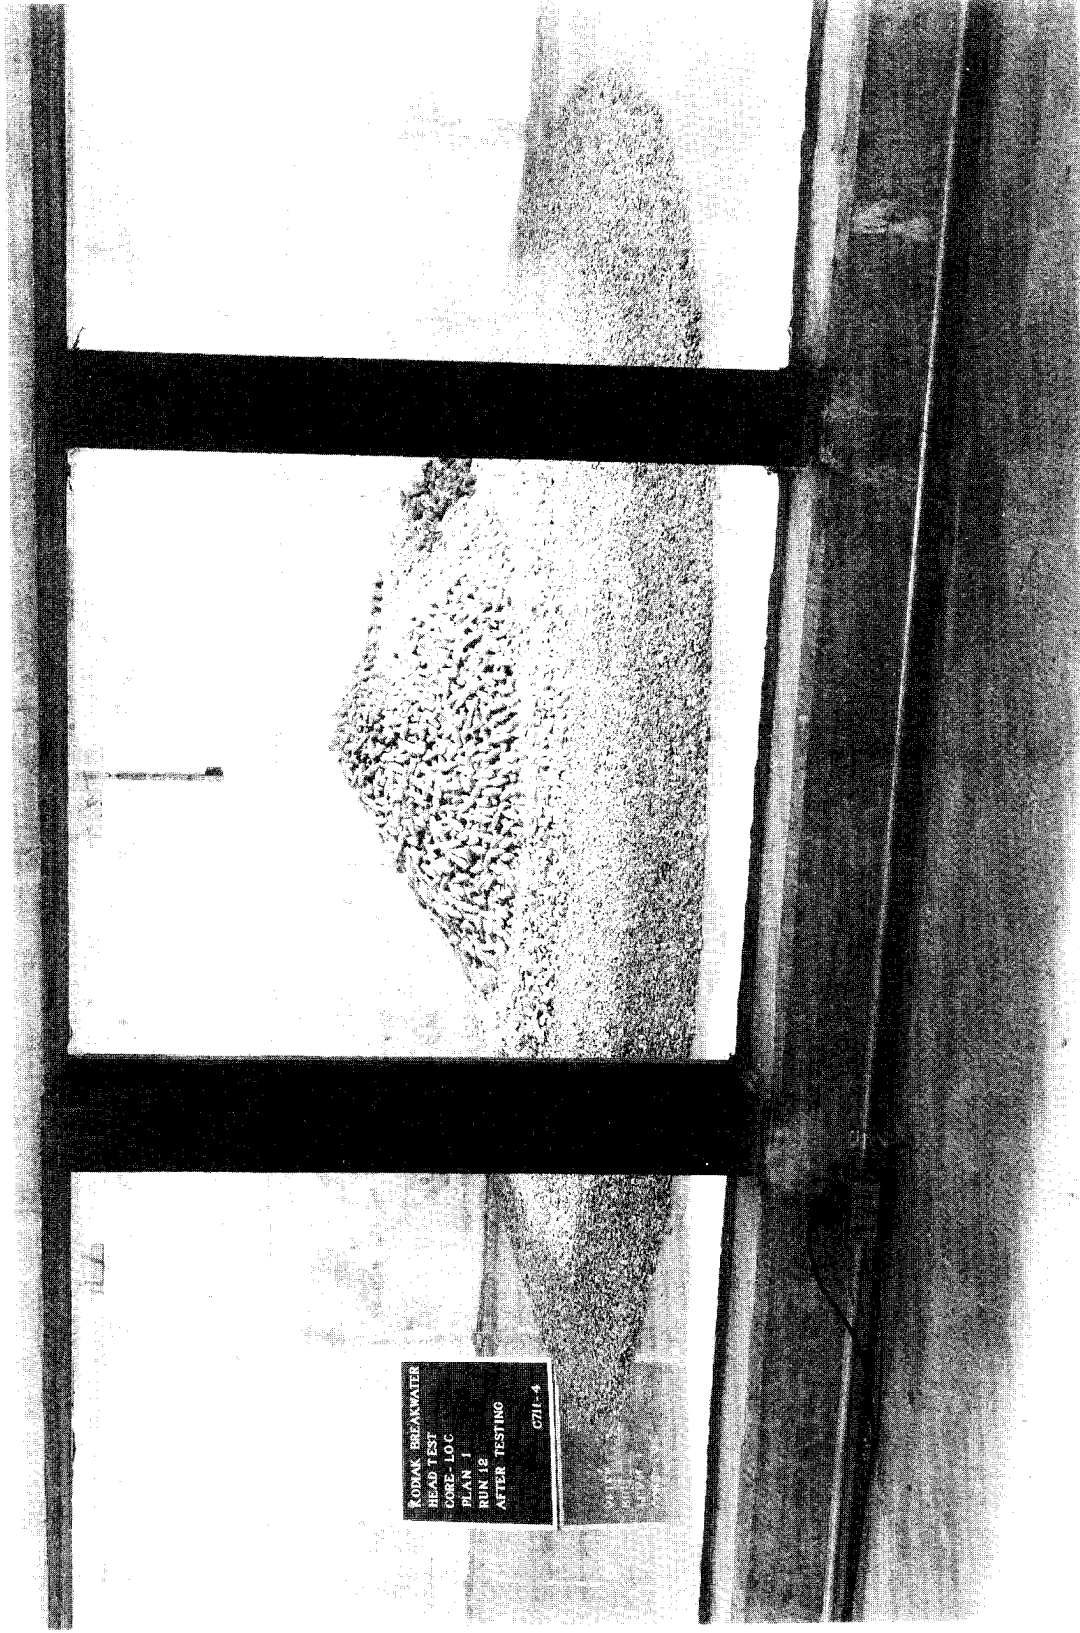
KODAK BREAKWATER
HEAD TEST
CORE-LOC
PLAN 1
RUN 12
AFTER TESTING
C711-4

Photo 9. End view of model breakwater Plan 1 after testing

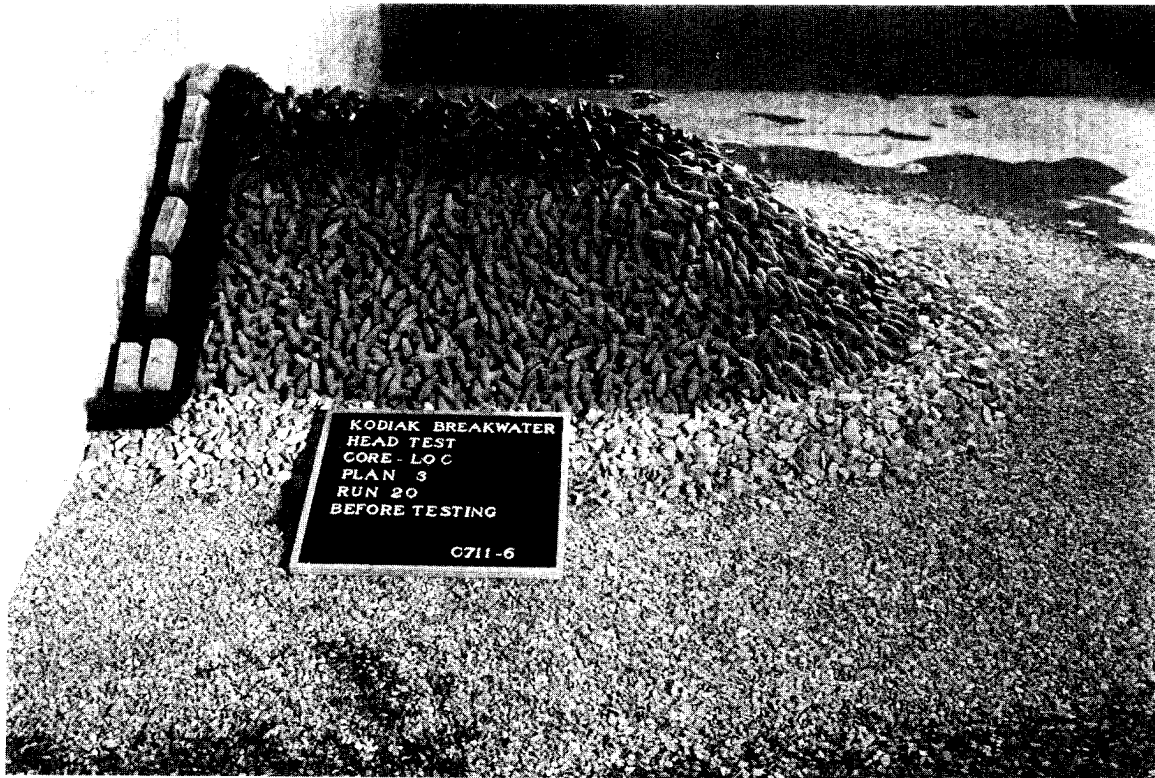
Photo 11. Sea-side view of model breakwater Plan 3 before testing

The sea-side slope and structure head were not rebuilt after Plan 2 testing. All Core-Locs were removed from the crest and harbor-side trunk, and the larger-sized B-stone on the harbor-side trunk were removed. The crest and harbor-side trunk were then rebuilt. Plan 3 used 143 more Core-Loc units than Plan 2 due to placing the Core-Locs further down from the crest on the harbor-side trunk. A strip of horsehair 0.15 m (0.5 ft) wide was placed over the structure along the wall from the sea-side toe to the harbor-side toe to protect units near the wall from wall effects. Photos 11 and 12 show the sea side and harbor side, respectively, of Plan 3 before testing.

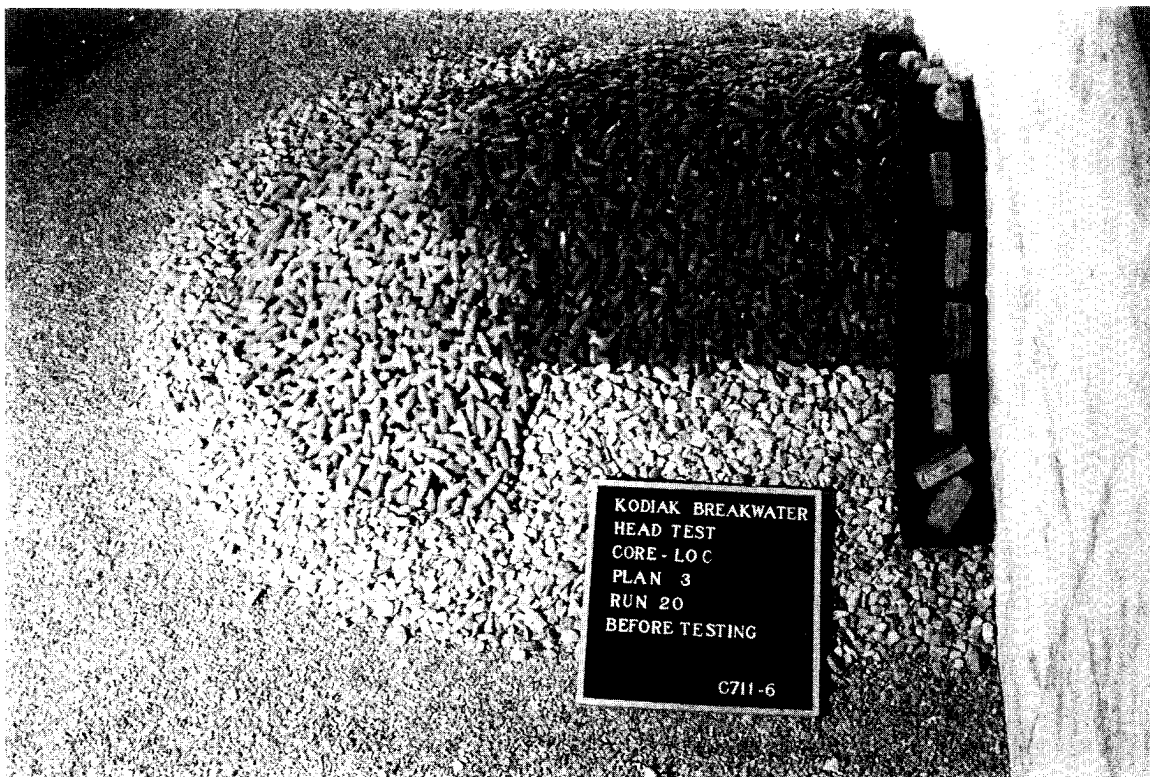
Photo 12. Harbor-side view of model breakwater Plan 3 before testing

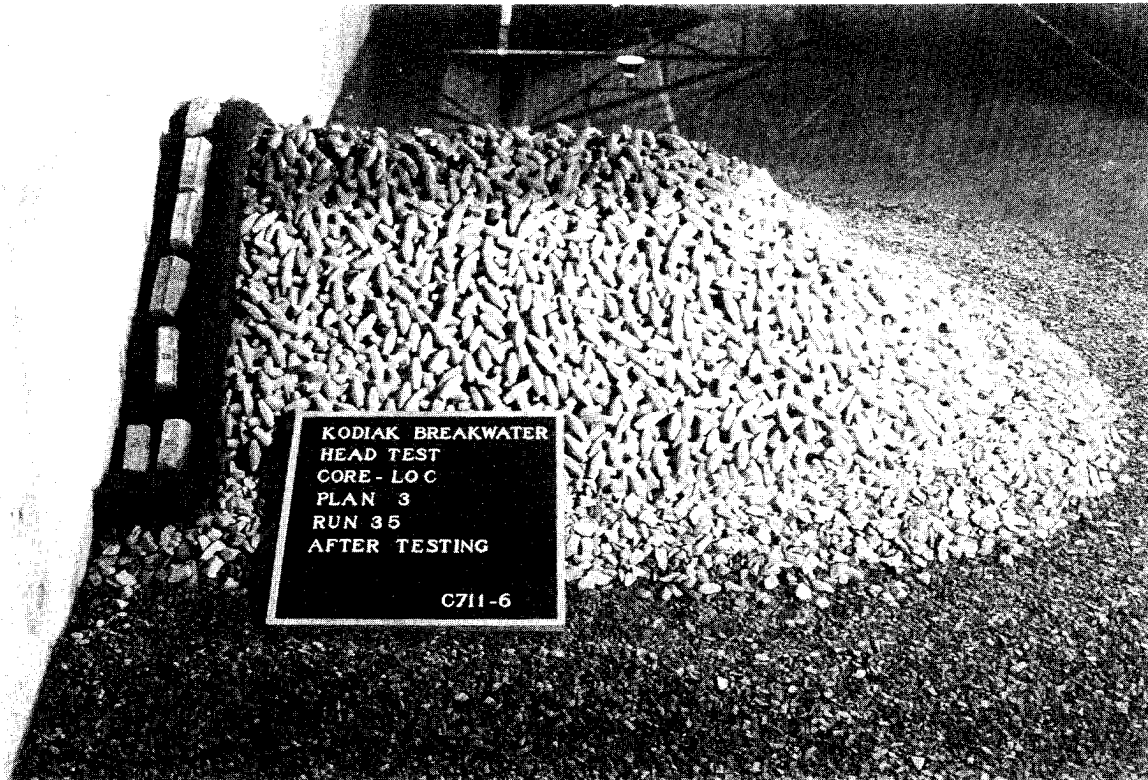
Photo 13. Sea-side view of model breakwater Plan 3 after testing

Three runs of 48 min each were conducted at $T_p = 14.0$ sec and $H_{m0} = 2.1$ m (7.0 ft). During the third run, the structure failed when heavy overtopping pushed Core-Loc units down the harbor side of the trunk with enough force to push the B-stone on down the slope in front of the Core-Locs. There was no evidence of undermining. The 14-sec waves overtopped the structure trunk as a surging breaker, causing a very heavy downrush on the harbor side. Because the B-stones were placed by dumping, they were not interlocked into a matrix as is the case with individually placed and seated armor units. The B-stone therefore had little resistance to sliding. Hydrodynamic forces on the Core-Locs were sufficient to push the B-stone downslope and cause a slumping failure in the Core-Locs.
